STAR Case

Case Number: S1123000040

Customer Complaint Of Damp Carpet And/Or Waterleak

Water Leaks

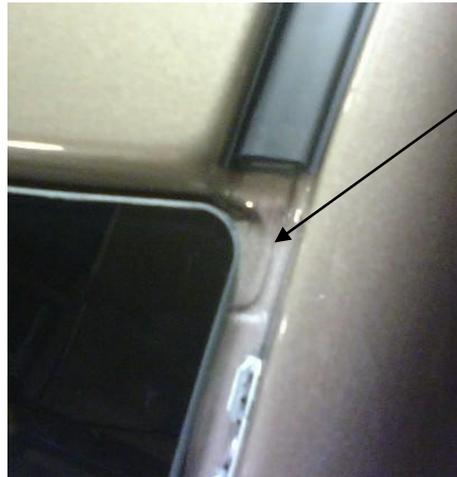
Note: A special area of concern is where the windshield and body seams meet (upper a-pillar), which is shown below:

Sealer skips (or pinholes) can be seen along the exposed body seams.

2. Once the windshield molding is removed, inspect for sealer skips. Apply Mopar Glass Sealer: Part No. 04318088 to any skip in the urethane around windshield.
3. For sealer skips in the A-Pillar body seam apply 3M – Flexiclear Body Seam Sealer.
4. Prior to re-assembly, re-test the area to ensure it is properly sealed.
5. Carefully reinstall windshield molding. Refer to the installation procedure available in DealerConnect> Service> TechCONNECT> Service Info> 23-Body> Weatherstrip> Seals> WEATHERSTRIP, Windshield, A-Pillar> Installation.

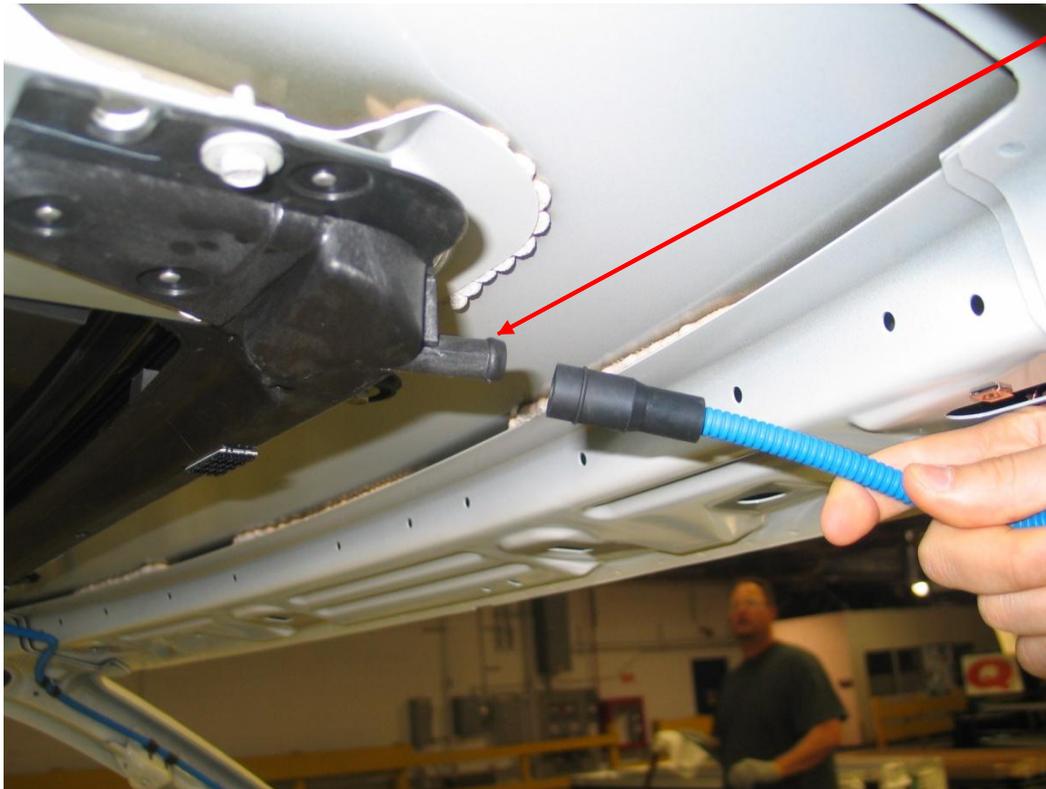
Barb

1. Inspect for water dripping from Overhead Console, also inspect for water marks/stains and/or dampness on Headliner.
2. Lower the headliner. Refer to the removal procedure available in DealerConnect> Service> TechCONNECT> Service Info> 23-Body> Interior> Headliner> Removal. Inspect all four sunroof drains and insure all connections are secure to each barb.

3. Verify that all four drain tubes are securely fastened, prior to re-assembly. Re-test the area by opening sunroof and using a small cup of water, slowly pour water into sunroof trough to ensure water flows and the drains are properly sealed.
4. Install Headliner. Refer to the installation procedure available in DealerConnect> Service> TechCONNECT> Service Info> 23-Body> Interior> Headliner> Installation.

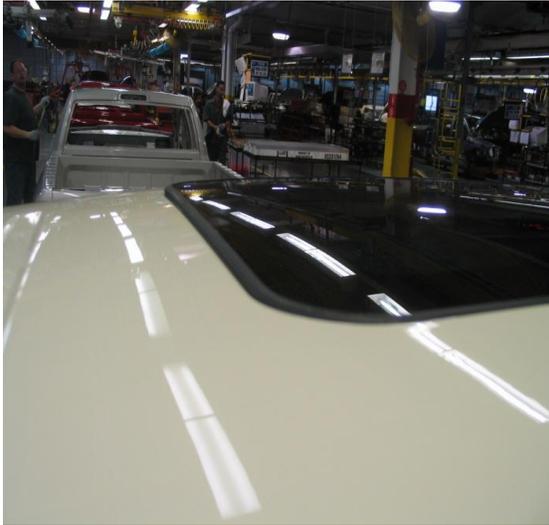
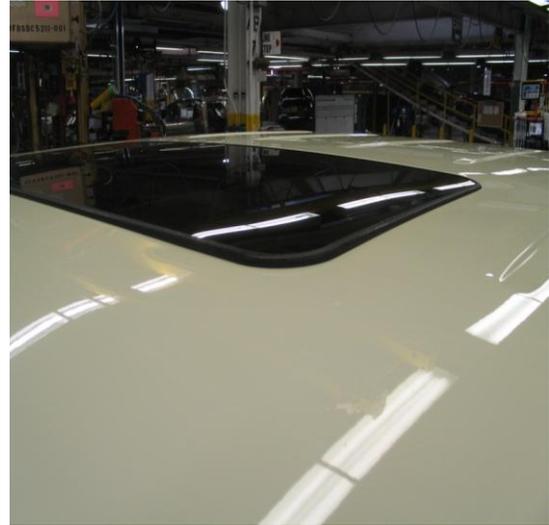
1. Using the specifications listed in DealerConnect> Service> TechCONNECT> Service Info> 23 – Body> Sunroof> GLASS, Sunroof> Adjustments> Adjustment. Visually inspect sunroof glass flushness to roof panel.

2. If adjustments need to be made to the sunroof glass. Refer to the procedure available in DealerConnect> Service> TechCONNECT> Service Info> 23-Body – Sunroof> Glass, Sunroof> Adjustments, for proper height and gap tolerances.

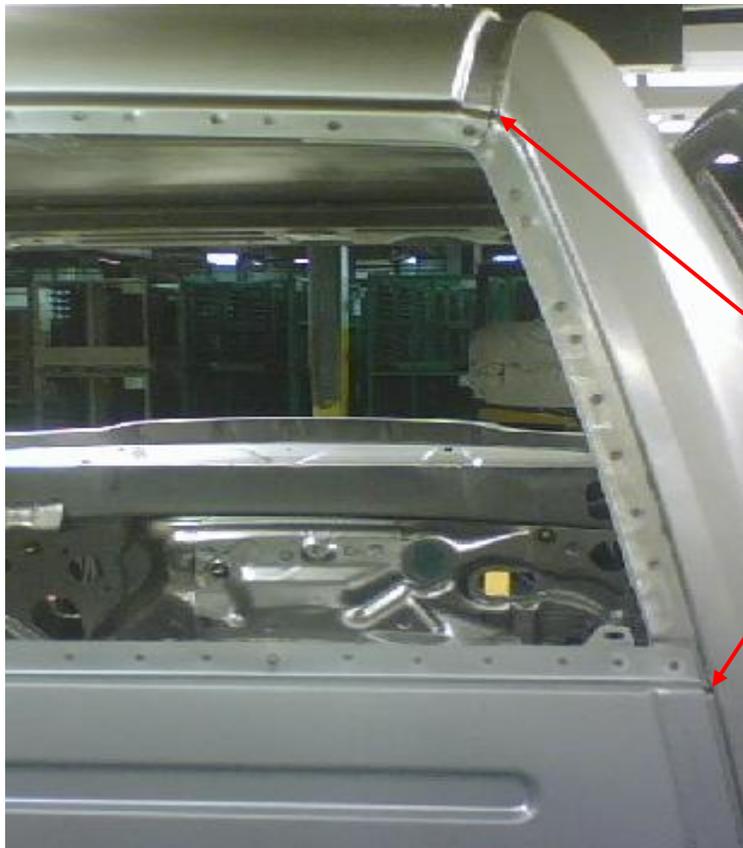
Rat Hole Locations

1. Inspect both areas indicated by **Red Arrows**.

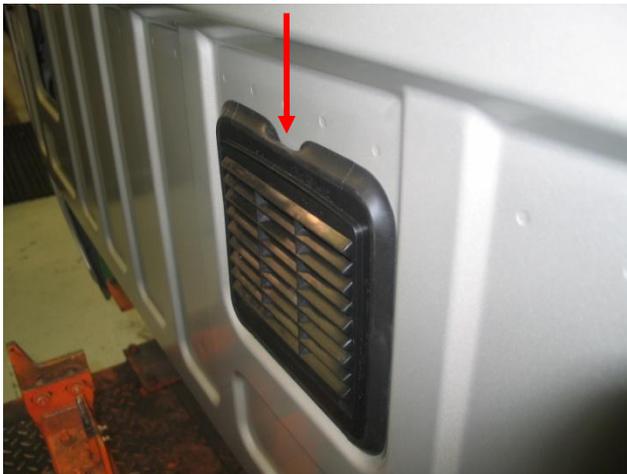
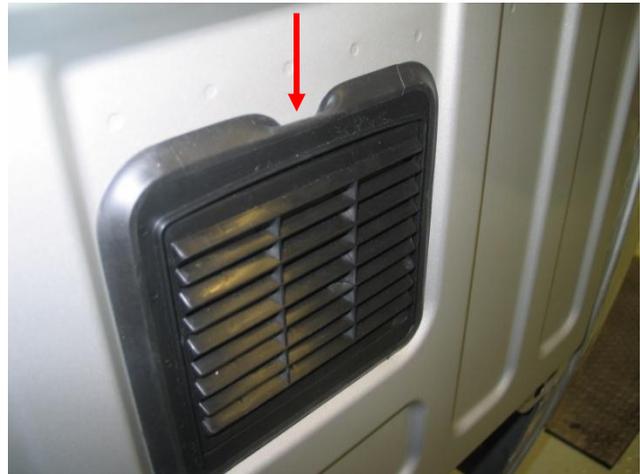
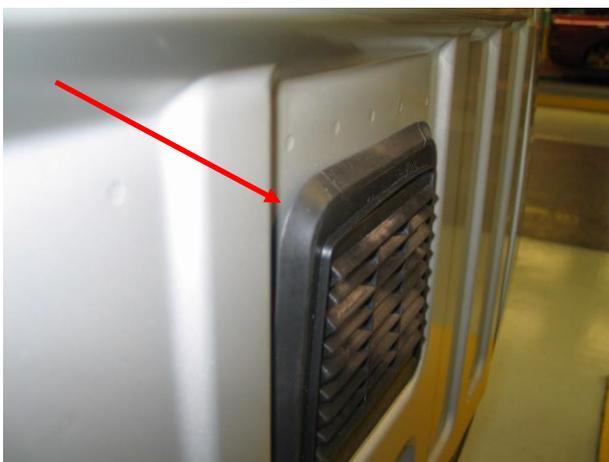
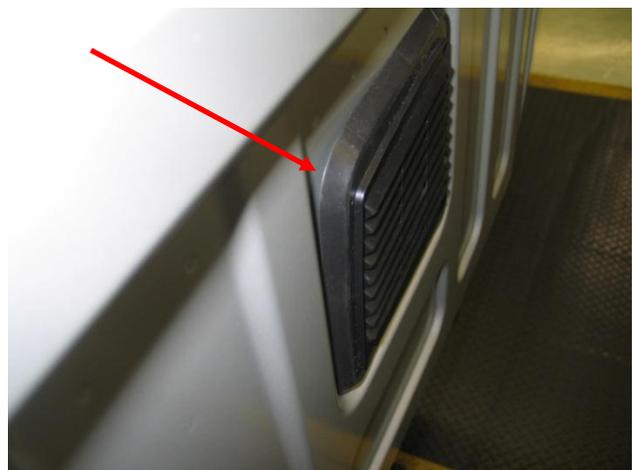
1. Review examples of what to look for and insure they are properly installed and seated against the body of the vehicle.
2. If any of the conditions are found remove exhauster from vehicle inspect for tearing or ripping of the seal. If seal has no tears or rips then reinstall on to vehicle making sure it clicks in on all four corners and that the seal is not rolled.
3. If seal is damaged or torn then replace body exhauster p/n 55055998AF.
